Concept of Dewatering at Hitech Industrial Estate

Prepared by Seah, Tian Ho

on behalf of Sino-Thai Engineering and Construction Public Co., Ltd.

Dated 10th November 2011

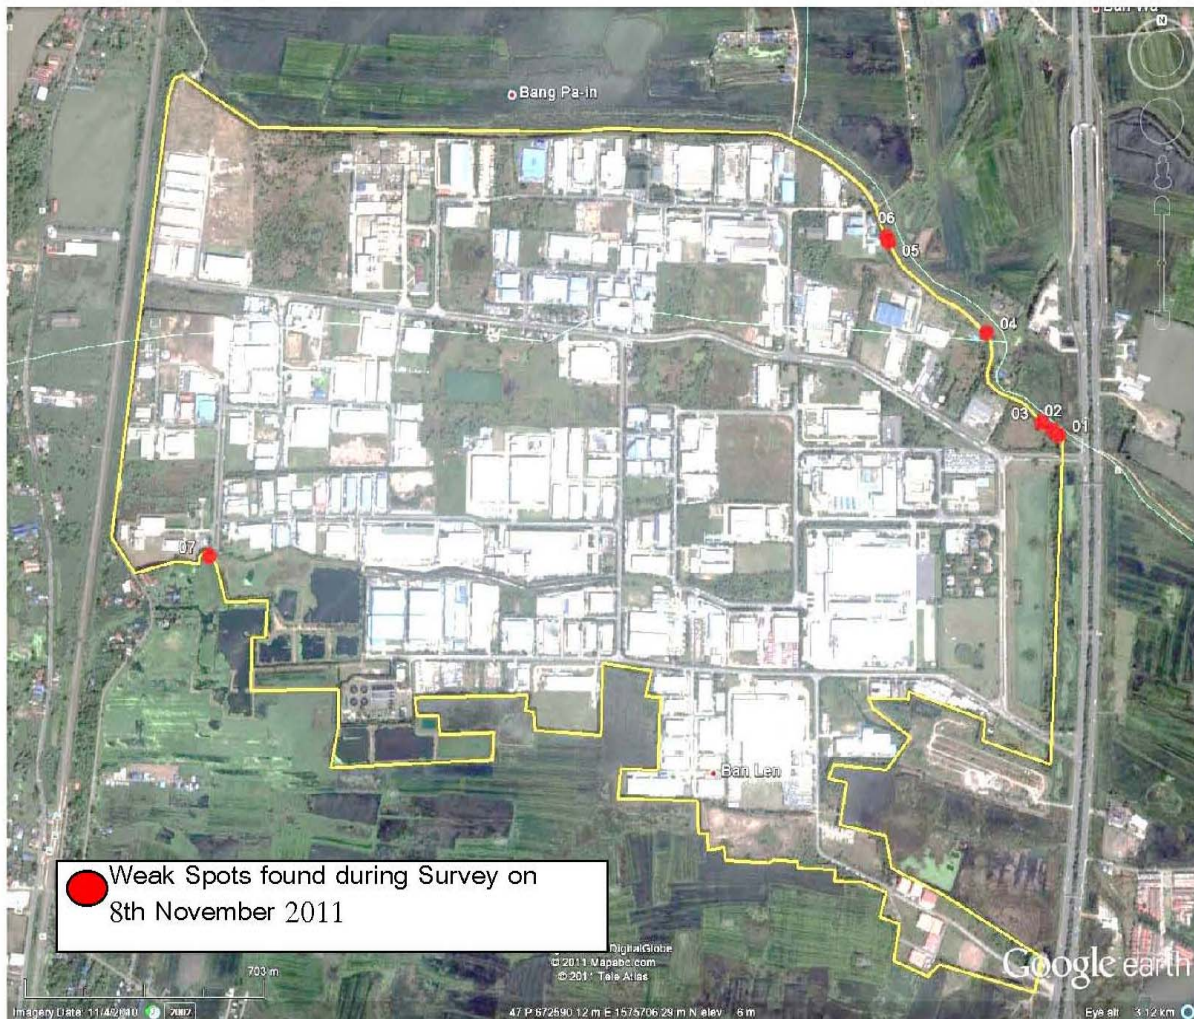
Hitech, with the assistance from the *Thai Royal Army*, had started repairing and strengthening the perimeter dike of the Hitech Industrial Estate immediately after section of the dike was breached in October. Most of the dike strengthening works have been completed on 10th November 2011, except for some small sections (at 7 locations) which may require further improvement as shown in Figure 1.

Figure 1 Locations of Weak Spots discovered on 8th November 2011 by Sino-Thai Team

1. **Repairing and strengthening of existing dike.** The Royal Thai Army had started repairing and strengthening of the existing dike immediately after the breaching of the first dike back in October. The technique of remedies include replacement of weak fill materials, placing of sand bags or big bags between installed wooden piles, raising of dike elevation by sand bags and clayey fill etc.. Additional strengthening will be done on those minor weak spots reported by Sino-Thai team on 10th November 2011, which will be expected to be completed by 14th November 2011.

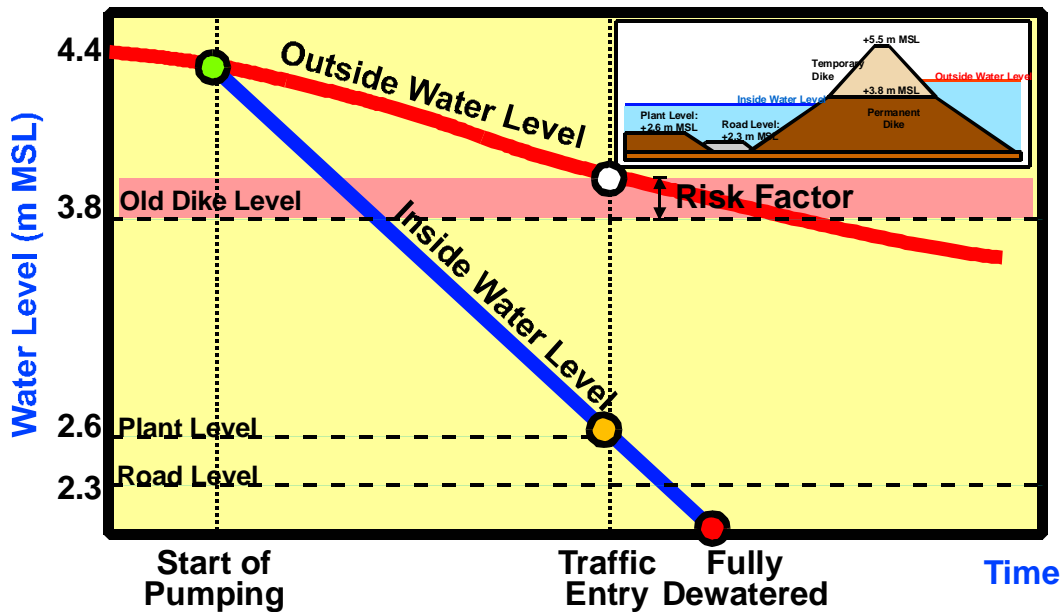
Figure 4 Risk of Dike Breaching if Outside Water Level is above +3.8 m MSL

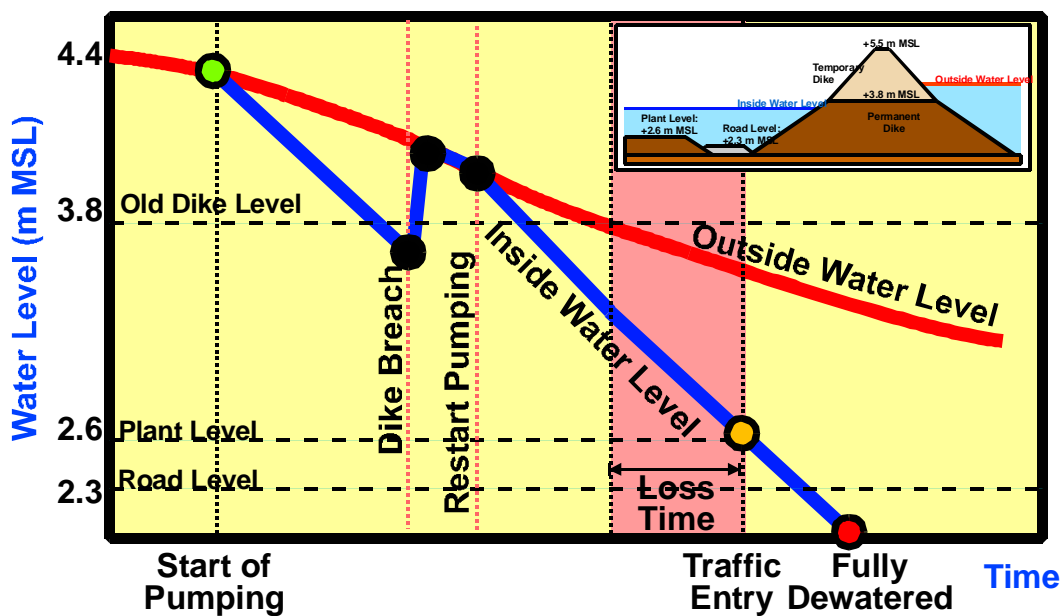
3. **Risk of dike breaching during pumping when outside water level is above +3.8 m MSL.** If pumping starts before the outside water level reaches +3.8m MSL, then there is a higher risk of dike breaching during pumping. The failure of dike will raise the inside water level to match the outside water level within a very short period with schematic shown in Figure 7. During repair of dike, the inside water level will equilibrate with the outside water level. Once the pumping has restarted, then the drawdown will continue. The consequence of the dike breaching with high outside water level is *considered minor* with minimum risk to safety, but there will be a loss in pumping time. Therefore, an early start in pumping is considered acceptable with some risk in time loss if the dike failed.

Figure 7 Water Level Condition during Dike Failure
