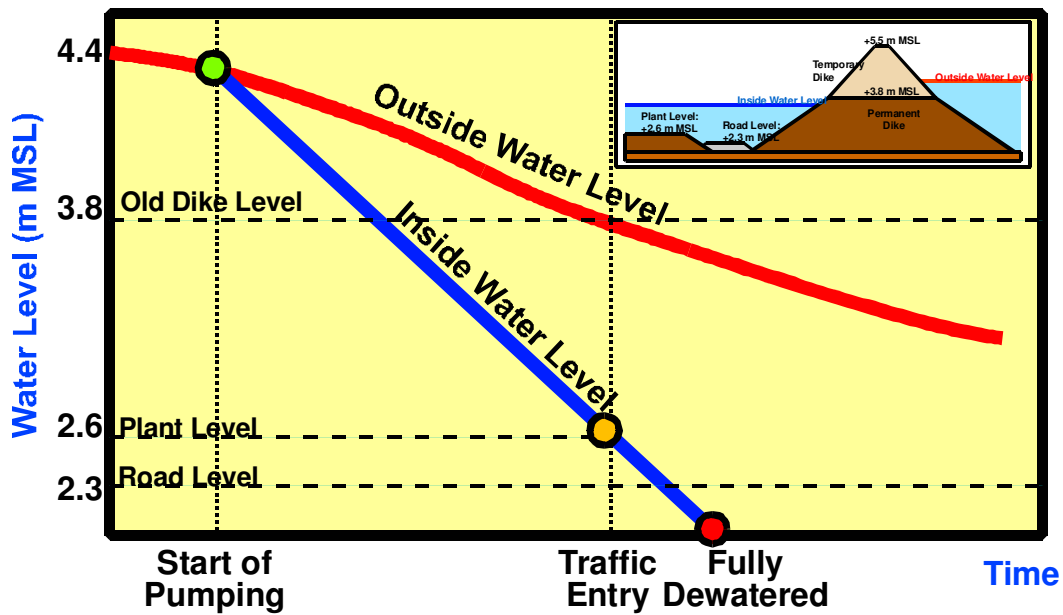
Figure 6 Ideal Condition of Drawdown

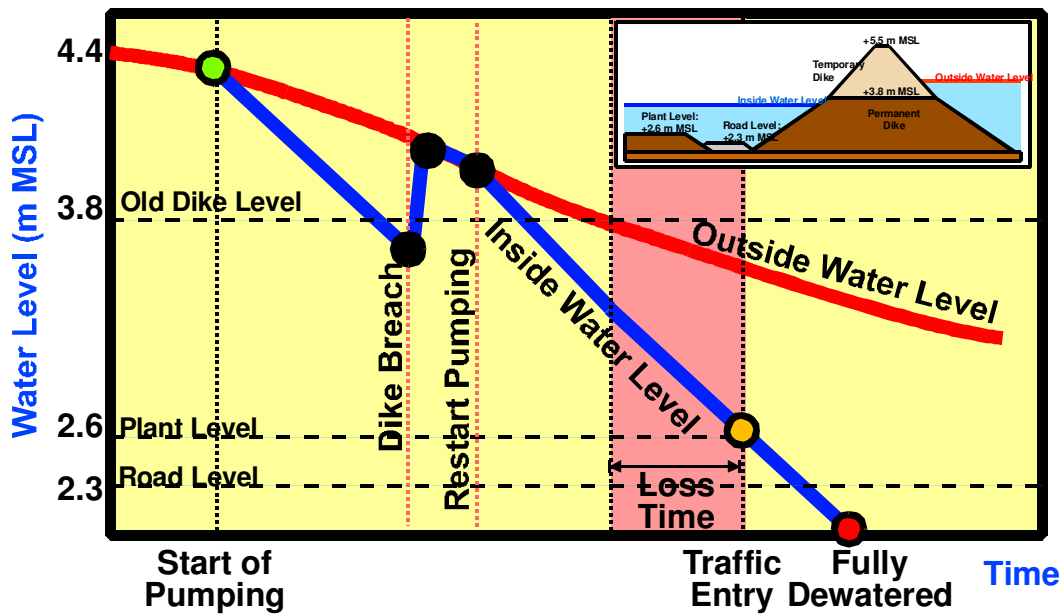
1. **Risk of dike breaching during pumping when outside water level is above +3.8 m MSL.** If pumping starts before the outside water level reaches +3.8m MSL, then there is a higher risk of dike breaching during pumping. The failure of dike will raise the inside water level to match the outside water level within a very short period with schematic shown in Figure 7. During repair of dike, the inside water level will equilibrate with the outside water level. Once the pumping has restarted, then the drawdown will continue. The consequence of the dike breaching with high outside water level is ***considered minor*** with minimum risk to safety, but there will be a loss in pumping time. Therefore, an early start in pumping is considered acceptable with some risk in time loss if the dike failed.

Figure 7 Water Level Condition during Dike Failure

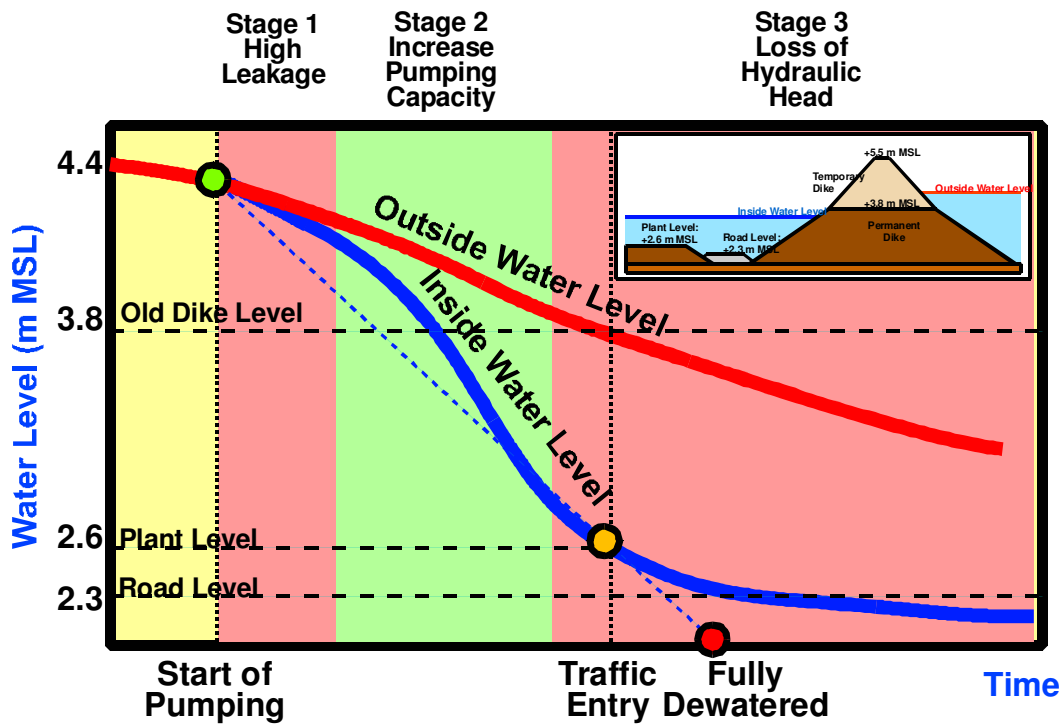
Figure 8 Expected Drawdown Time Curve

2. **Expected condition of drawdown.** A linear water drawdown within the estate will not be unlikely due to leakage through the dike at the top section (new fill) and low hydraulic head for full flow when the water reaches lower level. Figure 8 shows the possible stages of dewatering. During the initial pumping, large leakage through the new fill is expected, then the lowering of water will be low. To meet a particular target date, it may be necessary to increase the pumps half way through the dewatering process. For the low head condition in Stage 3, it will be necessary to distribute the mobile pumps over the boundaries for shortest the drainage paths which shall be discussed in detail soon.

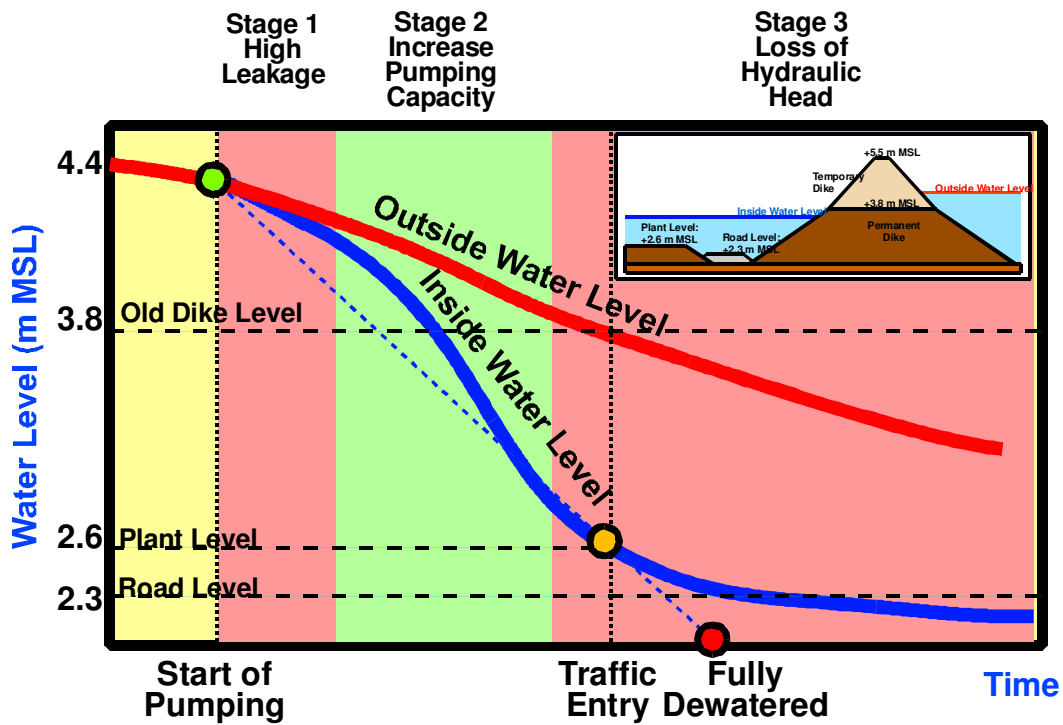
Figure 8 Expected Drawdown Time Curve
